Press Release
October 25th 2022

Delta work on remedial waterproofing for podium deck

The scope of the project was to offer a retrofit solution to a leaking podium deck. Works included closing up a leaking parapet, podium deck interface and side wall and providing a robust waterproofing solution to a residential structure in North Yorkshire.

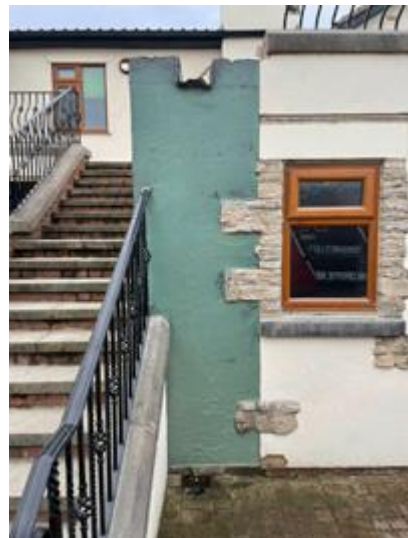
At the time of the construction, the podium deck had been waterproofed, however detailing to the parapet and surrounding wall was poor. The parapet and external wall itself had been left completely unprotected and vulnerable. Over time, water inevitably ingressed into the structure.

Dryfix proposed alterations to the existing structure which addressed the poor, at risk design which would allow for a continuous waterproofing system to be implemented between the existing parapet.

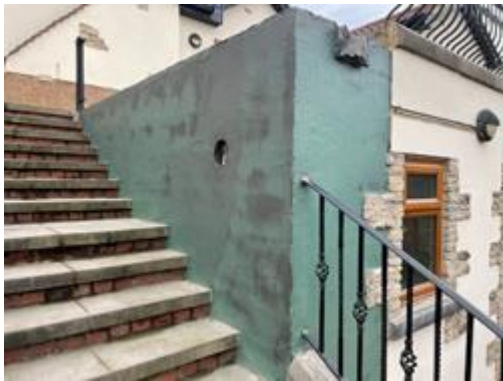
Following alterations to the structure, attention was given to the exterior junctions to ensure no water could ingress the structure via cavities as previously experienced by the owners. An application of Koster NB 4000 via construction interfaces was installed as a primary waterproofing solution to the additional blockwork.

Where different types of construction meet, there is always potential for movement. Koster NB 4000 would provide a long lasting, flexible approach in providing security for difficult junctions and the event of movement. Koster NB 4000 is an elastic, crack bridging, bitumen free, polymer modified, mineral hybrid coating suitable for external waterproofing application. Being UV stable, and not weather dependant, an ideal remedial solution for this project.
